INDOOR AIR QUALITY ASSESSMENT

**North Shore Community College
Maude Hall
562 Maple Street, Rte 62
Danvers, Massachusetts**

Prepared by:
Massachusetts Department of Public Health
Center for Environmental Health
Emergency Response/Indoor Air Quality Program
August 2005

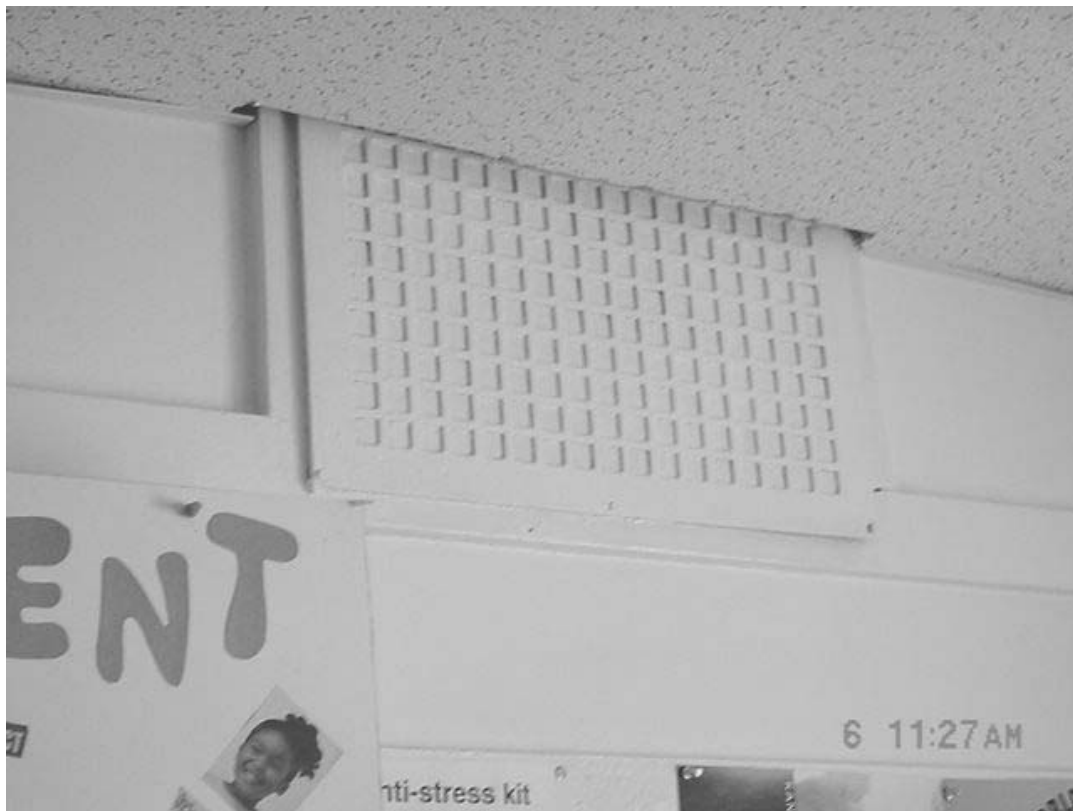
Picture 1

Ventilation in the original portion of the building is provided by a combination of natural gravity vents, open windows and transoms. The natural gravity vents and transoms were sealed throughout the building (Pictures 1 and 2). Exhaust ventilation is provided by wall vents ducted to a wind-driven turbine on the roof (Picture 3). The turbine was observed rotating during the assessment and some draw was detected from the vents in classrooms.

Sealed Gravity Supply Vent

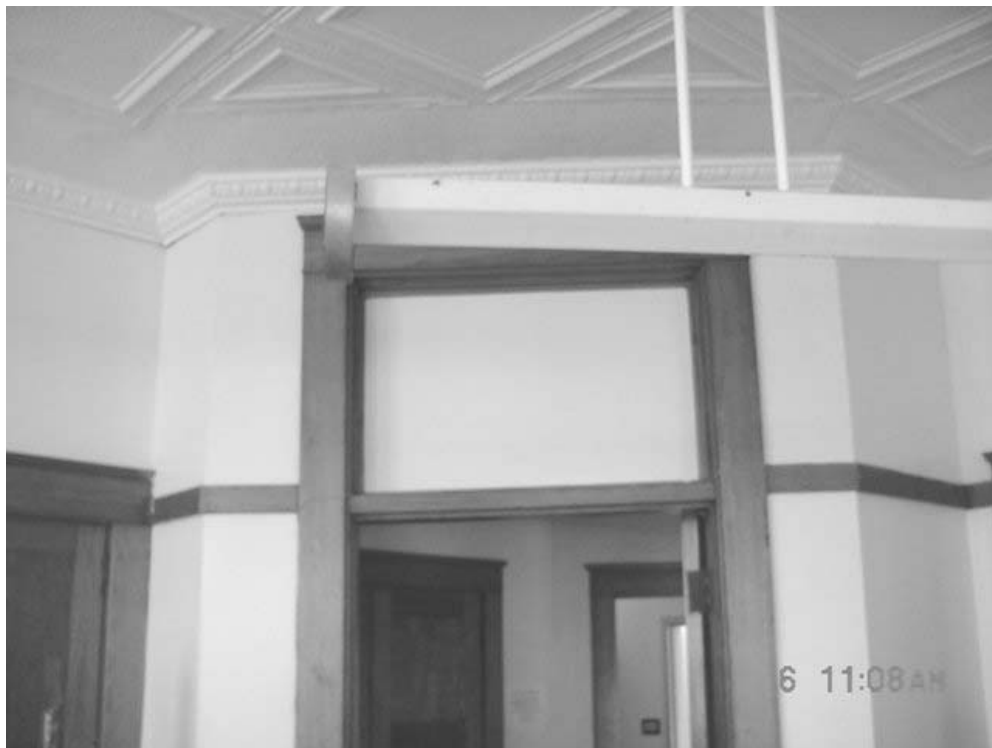
Picture 2

Sealed Transom

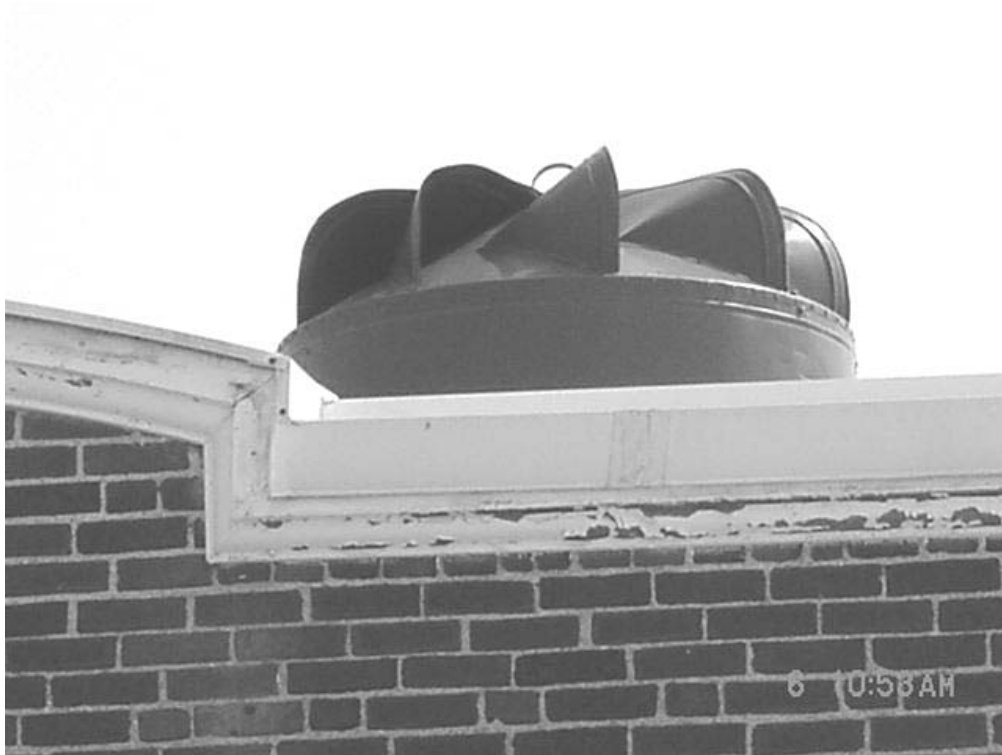
Picture 3

Wind-Driven Exhaust Turbine on Roof

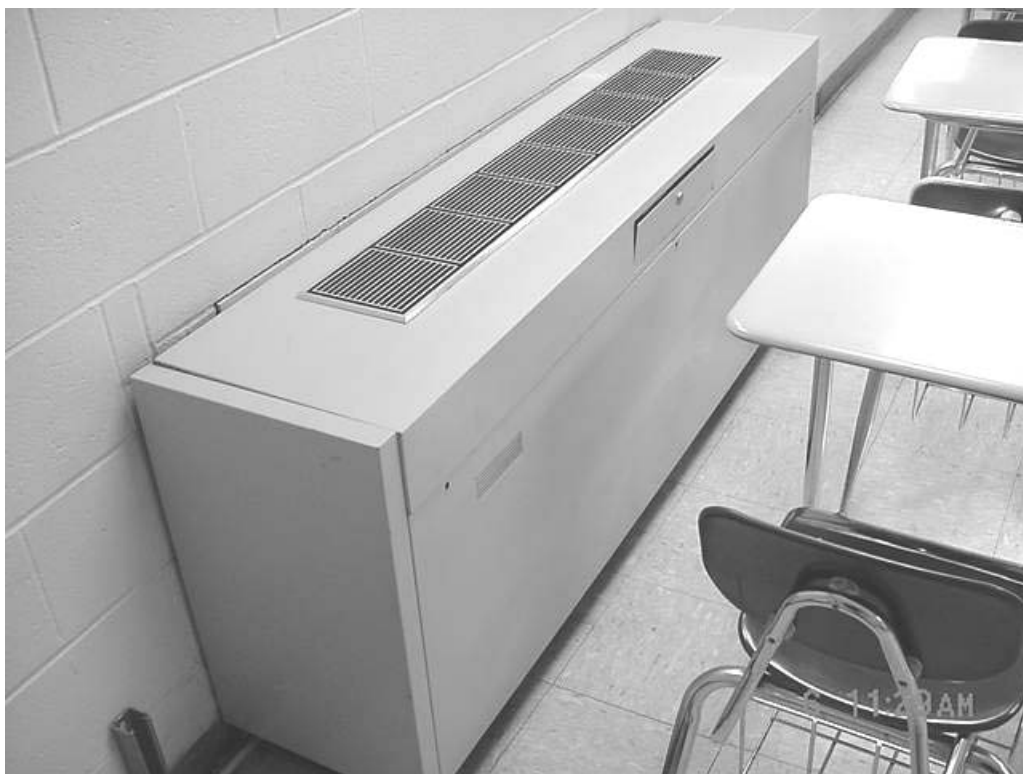
Picture 4

The 1970s portion of the building was designed to have fresh air mechanically supplied to rooms by unit ventilator (univent) systems (Picture 4). A univent draws air from outdoors through a fresh air intake located on the exterior walls of the building (Picture 5) and returns air through an air intake located at the base of the unit. Fresh and return air are mixed, filtered, heated and provided to classrooms through an air diffuser located in the top of the unit ([Figure 1](#)). Univents were found deactivated in all areas and appeared not to have been operated for some time. Obstructions to airflow, such as items on top of univents and/or tables and desks in front of univent returns, were also seen in a number of areas. To function as designed, univents must be activated and remain free of obstructions.

Classroom Univent

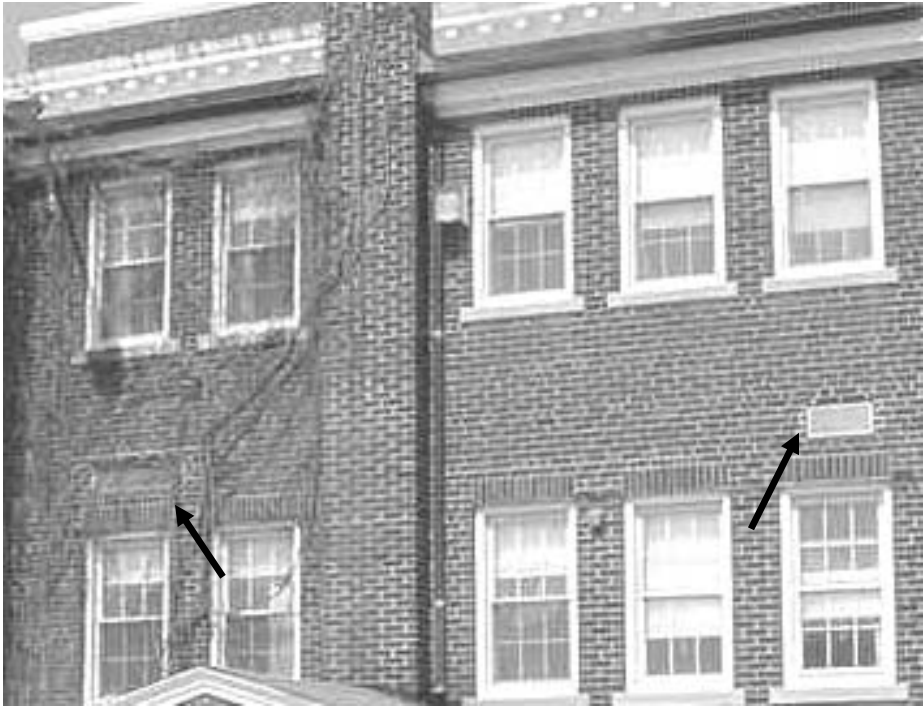
Picture 5

Fresh Air Intakes and Exhaust Vents

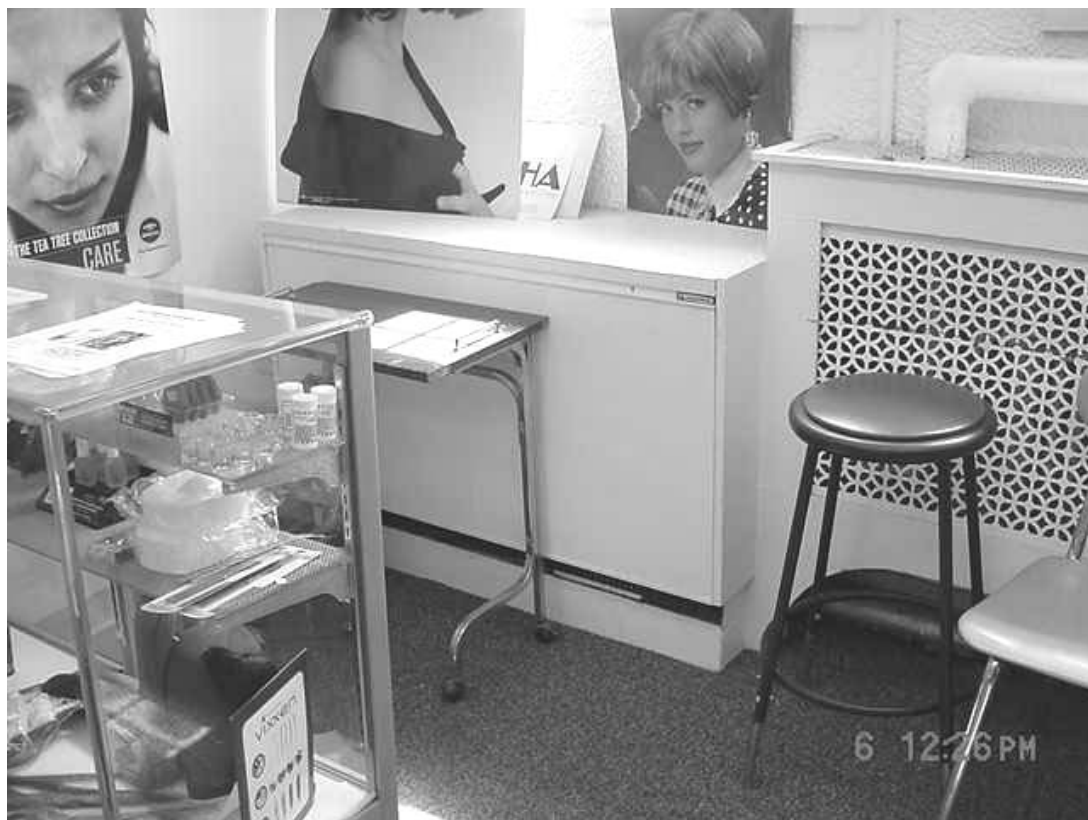
Picture 6

Exhaust ventilation was designed to be provided by unit exhaust ventilators (Picture 6), which are much like a univent but remove air *from* the building. A unit exhaust ventilator contains a fan, which draws in and forces air out through an exhaust vent on the exterior of the building (Picture 5). As with the univents, all unit exhaust ventilators were deactivated during the assessment and appeared not to have been operated for some time.

Unit Exhaust Ventilator

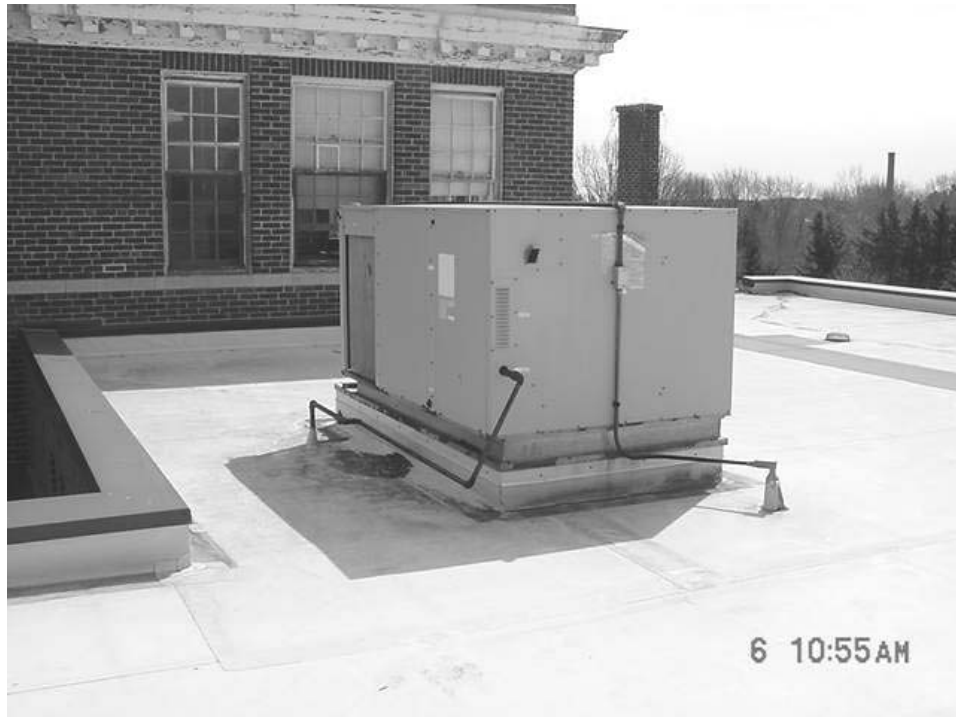
Picture 7

Portions of the building are serviced by a rooftop air handling unit, which provides heating and air conditioning (Picture 7). The AHU was examined by MDPH staff; no intake for the introduction of fresh air could be identified. Therefore it appears that the AHU recirculates air only. Without sufficient supply and exhaust ventilation, environmental pollutants can build up and lead to indoor air quality complaints.

Rooftop AHU

1. Contact an HVAC engineering firm for a full evaluation of the ventilation system and its control system (e.g., pneumatic controls, air intake louvers, thermostats). This measure is strongly recommended, given the age, physical deterioration and availability of parts for the HVAC system
2. Consider having exterior walls re-pointed and waterproofed to prevent water intrusion. This measure should include a full building envelope evaluation.
3. Repair/replace loose/broken windowpanes and missing or damaged window caulking building-wide to prevent water penetration through window frames.
4. Contact an HVAC engineering firm for a full evaluation of the ventilation system. Considering the age, physical deterioration and availability of parts of the HVAC system, an evaluation is strongly recommended for proper operation and/or repair/replacement of the ventilation system.

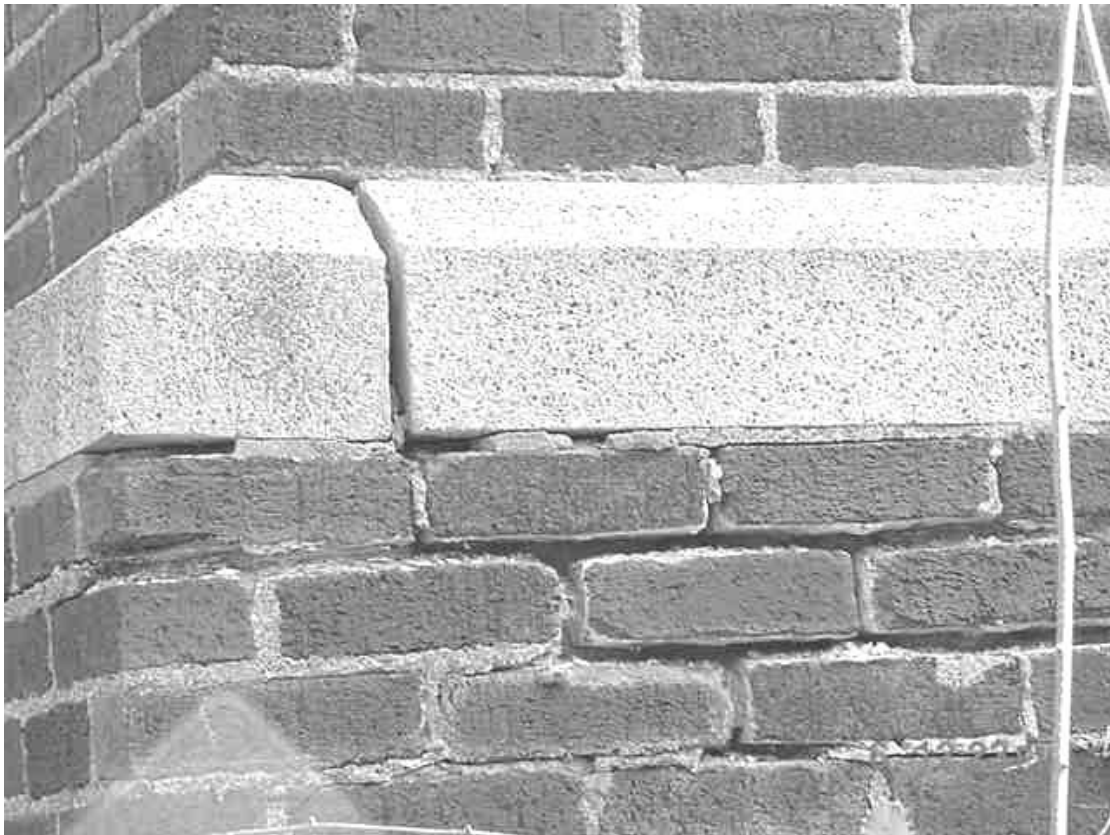
Picture 8

MDPH staff examined the outside perimeter of the building to identify potential breaches in the building envelope that could provide a source of water penetration. Several potential pathways for moisture to enter the building were identified, particularly cracks or missing/damaged mortar around exterior brick (Pictures 8 and 9), and rotted wood and spaces around window frames (Picture 10). Over the years, these breaches in the building envelope have resulted in water penetration and staining/damage to building materials (Pictures 11 to 15).

Missing/Damaged Mortar around Exterior Brick

6. Contact a masonry firm or general contractor to repair holes/breaches in exterior walls to prevent water penetration, drafts and pest entry.
7. Repair/replace broken windows; re-seal loose window frames as needed to prevent drafts and water penetration.

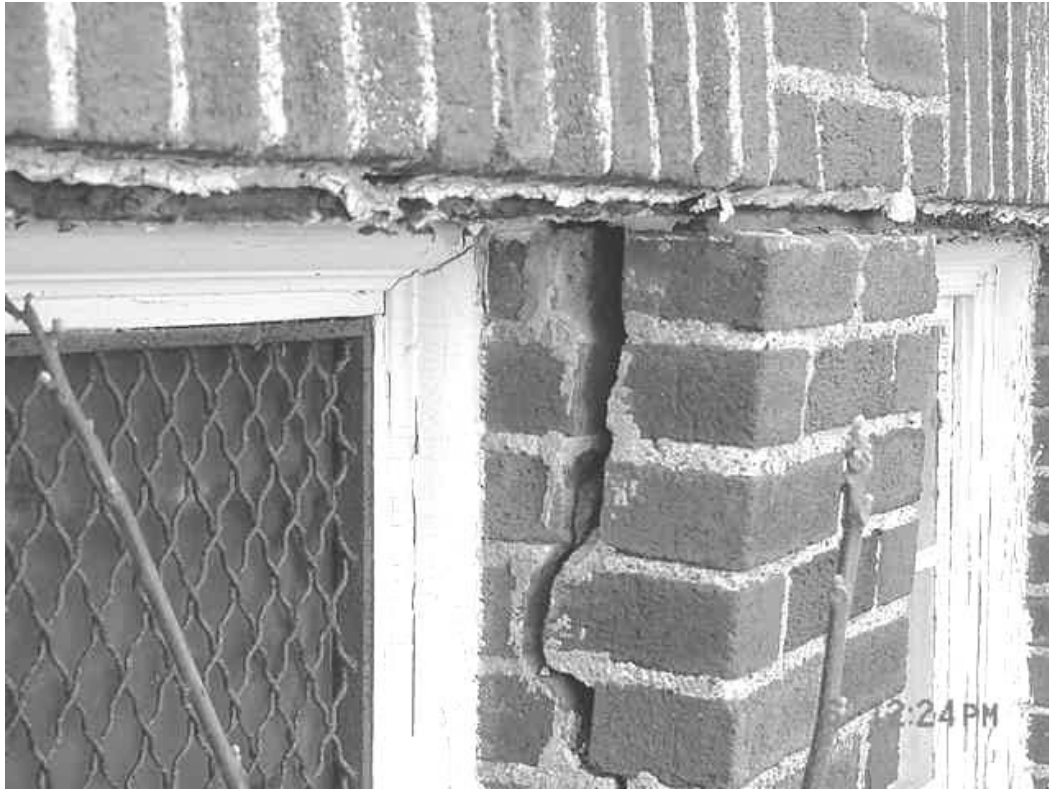
Picture 9

Cracked, Missing/Damaged Mortar around Exterior Brick and Window Frames

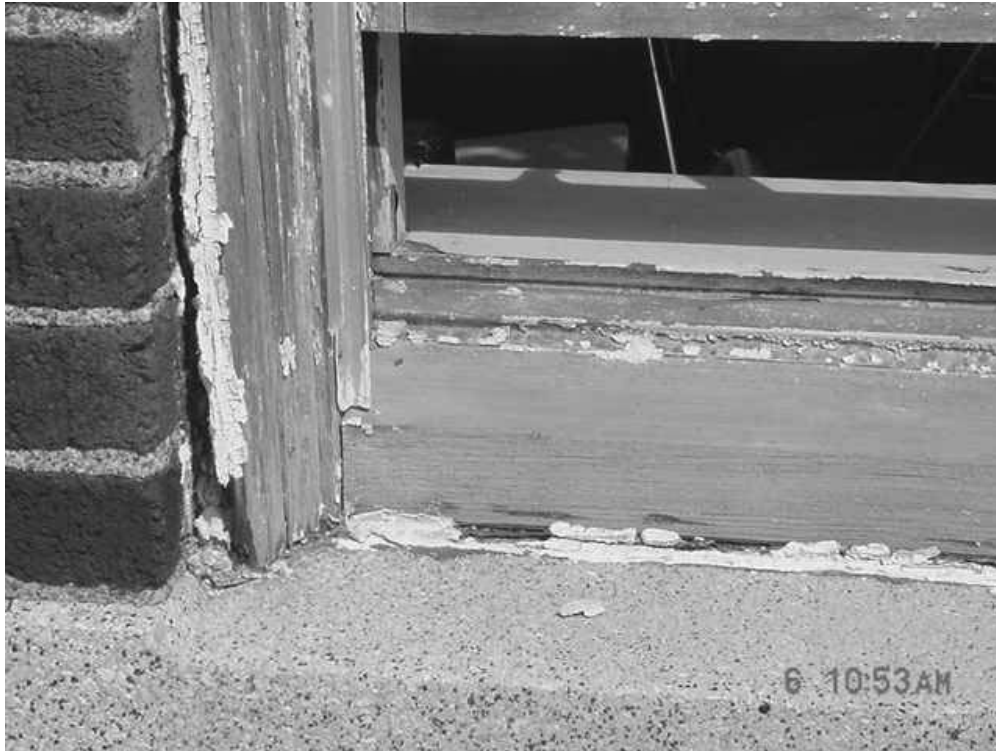
Picture 10

Rotted Wood, Missing/Damaged Caulking around Window Frames

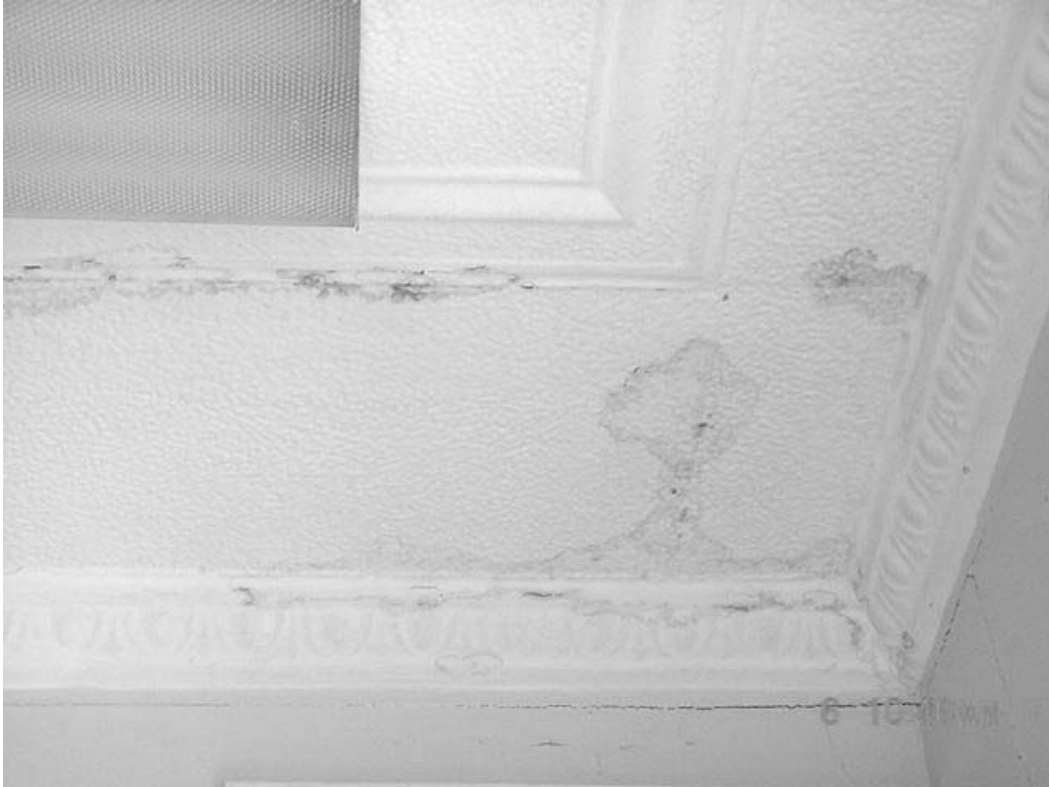
Picture 11

Water Stained Tin Ceiling on Second Floor

8. Replace any remaining water-stained ceiling tiles and wall plaster. Examine the area above and around these areas for mold growth. Disinfect areas of water leaks with an appropriate antimicrobial.
9. Refer to the resource manual and other related indoor air quality documents for further building-wide evaluations and advice on maintaining public buildings. These resources are located on the MDPH's website: http://mass.gov/dph/indoor_air.

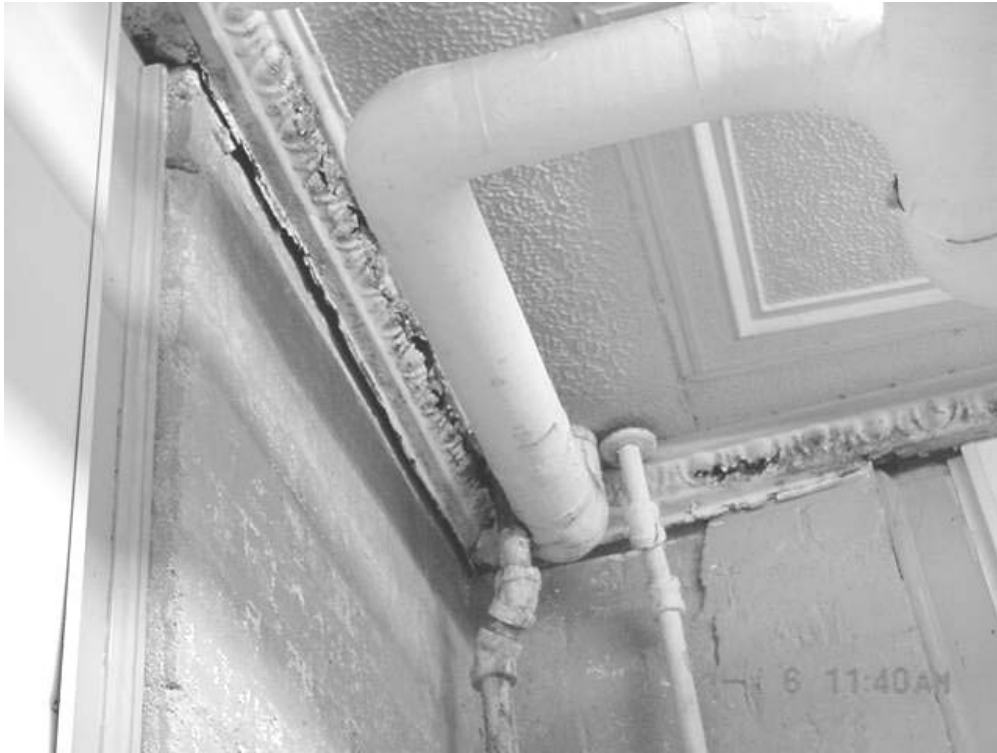
Picture 12

Water Stained Tin Ceiling in Basement

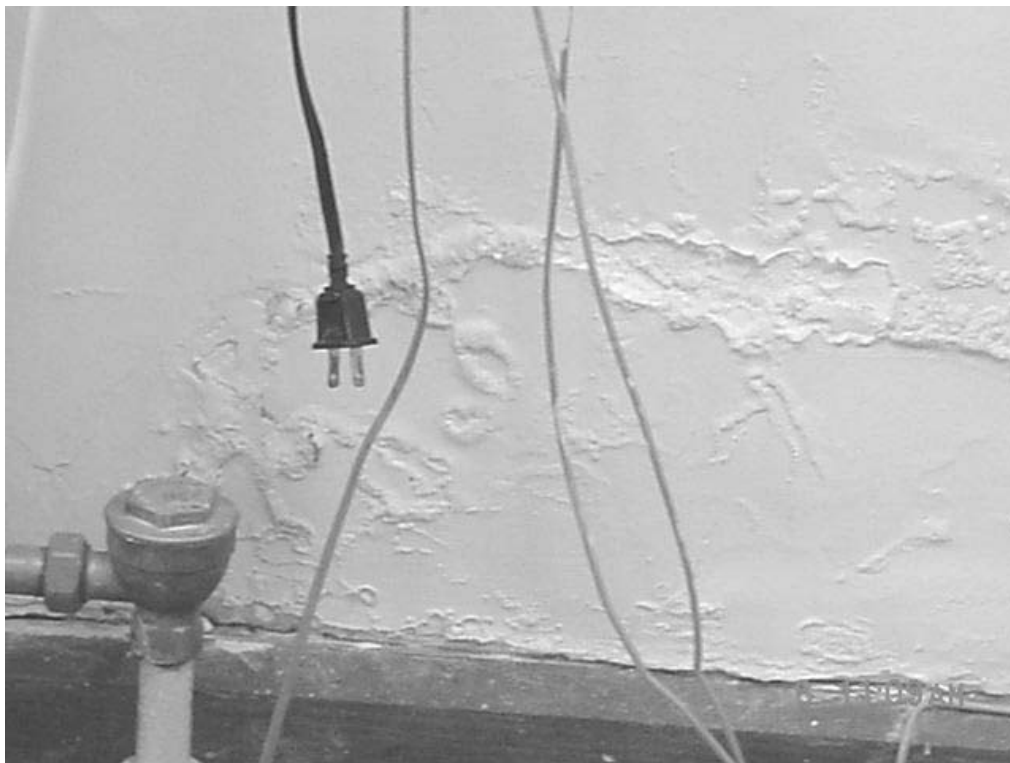
Picture 13

Pictures 13 through 15 show water-damaged plaster and efflorescence. Efflorescence is a characteristic sign of water damage to building materials, but it is not mold growth. As moisture penetrates and works its way through building materials, water-soluble compounds dissolve, creating a solution. As this solution moves to the surface, the water evaporates, leaving behind white, powdery mineral deposits.

Water Damaged Wall Plaster, Efflorescence and Peeling Paint

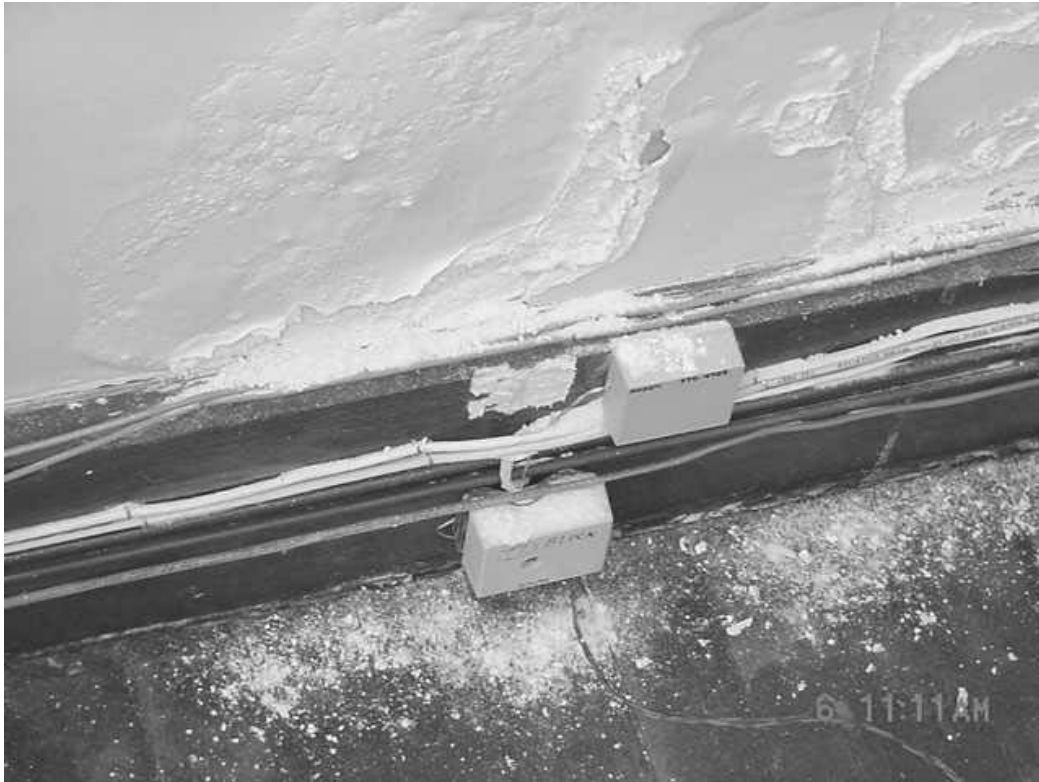
Picture 14

Water Damaged Wall Plaster, Efflorescence and Peeling Paint

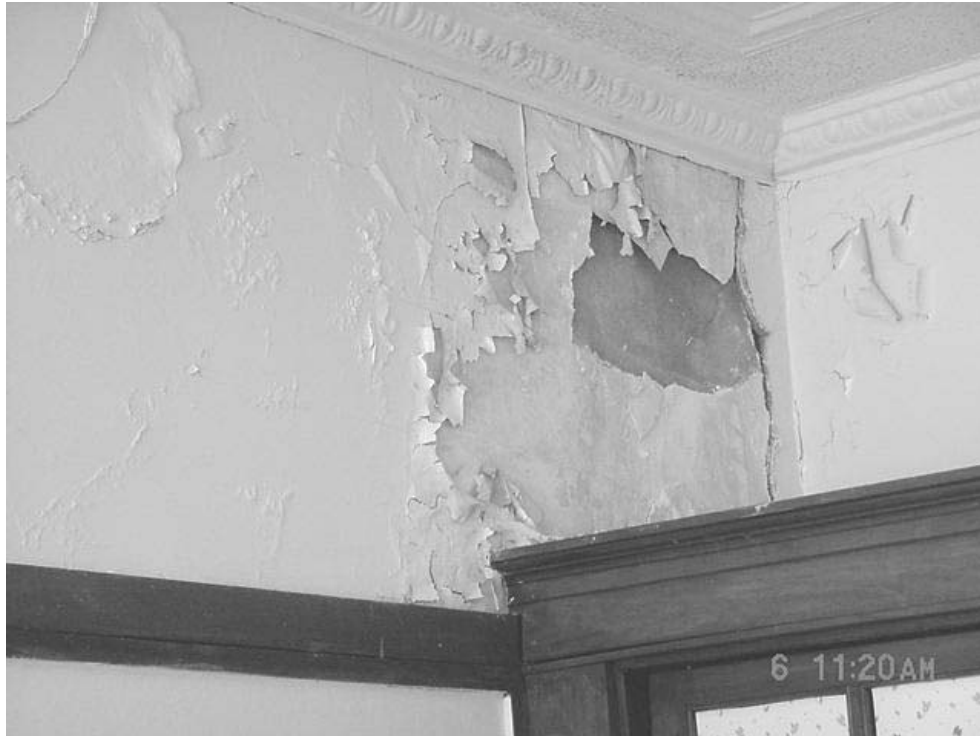
Picture 15

Water Damaged Wall Plaster, Efflorescence and Peeling Paint
